## **Dynamic Pressure Testing of a 155-mm Howitzer Ballistic Window Using a Closed Bomb Vessel**

**ARL-TR-5266**

**August 2010**

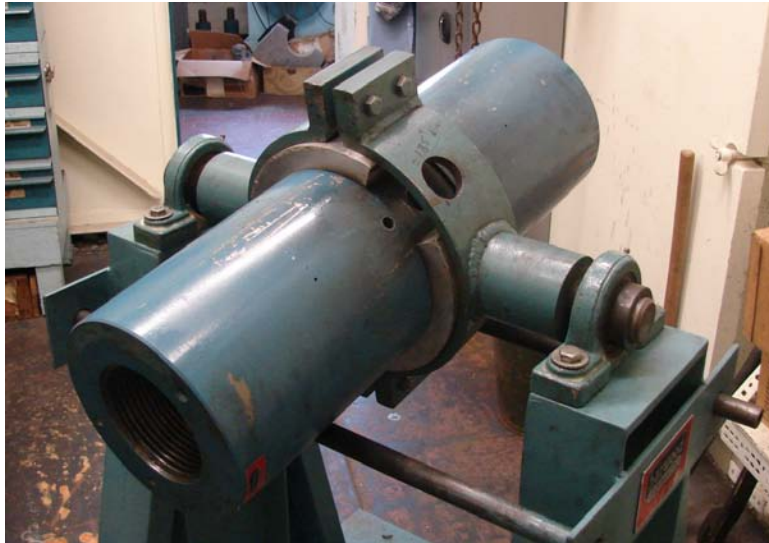
Figure 1. Double-ended closed bomb apparatus.

The equipment used for testing consisted of a Harwood Engineering double-ended closed bomb vessel (figure 1), a Kistler Type 607C high pressure sensor, a Kistler model 5100B1 dual-mode charge amplifier, fffg black powder, electric matches, M232A1 MACS propellant, and the XLCB data acquisition and reduction program (3, 4). However, in this experiment the only function of the XLCB program was to record a pressure-time history for each shot. Propellant properties and characterizations were irrelevant for this set of experiments.

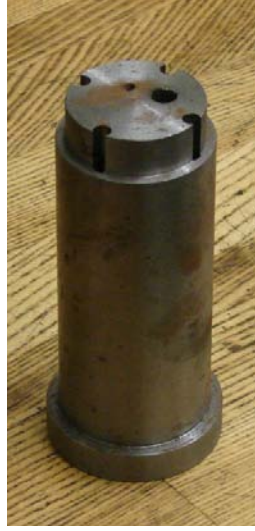
Figure 3. Modified closure cap/steel slug insert for closed bomb volume reduction.

The double-ended bomb had a chamber volume of ~465 cc and closure components identical to the Harwood 200-cc closed bomb, which is widely used for standard propellant testing (5). Because the chamber volume was much larger than needed, we designed and implemented a modified face plate/steel plug (figure 3) in order to take up volume inside the bomb, thus reducing its effective volume. This modification reduced the amount of propellant needed to reach desired pressures, and in turn, reduced the amount of stored energy in the closed bomb, therefore reducing associated safety risks. The appendix provides detailed drawings of the closed bomb modification needed in order to satisfy the testing requirements.
